Manhole Inspection Summary

Manhole # S71U__010MH

Insp Date: **4/22/08 2:10 PM**

Location Address: **1805 Dundalk Ave.**

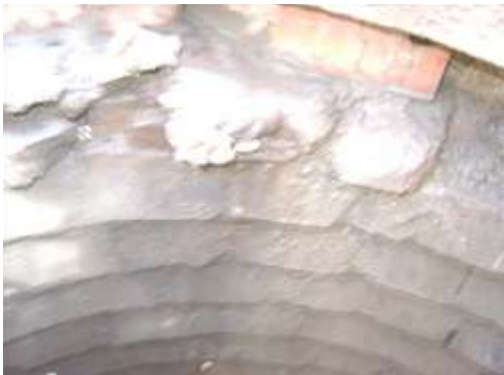
Defect 1

Condition: ☐ Sound ☐ Cracked ☐ Root Intrusion ☒ **Loose Brick** ☒ **Deteriorated**

loose bricks at frame adjustment

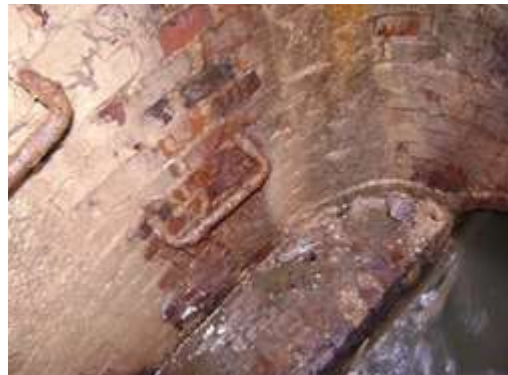
Defect 3

Infiltration: ☐ None ☒ **Joint** ☐ Cracks ☐ Mortar ☐ Roots ☒ **Wall**

infiltration from barrel wall

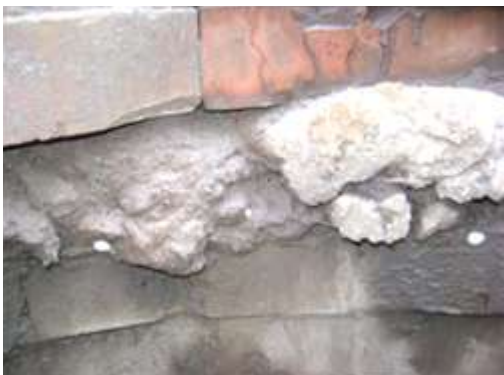
Defect 2

infiltration

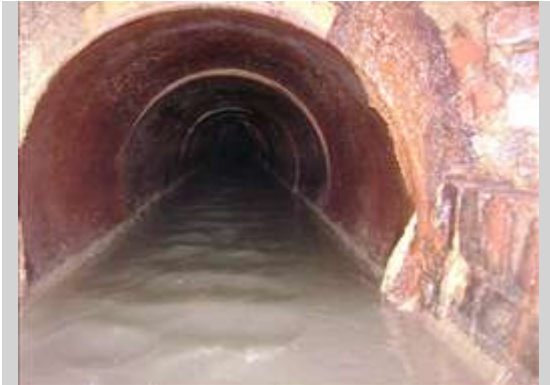
12 O'Clock Outflow

Pipe Height: **26.4** (in.) Rod and Bar (Angled)
Pipe Material: **Clay** ☐ Pipe Lined
Invert Depth: **16.71** (ft.) Flow Characteristics: **Turbulent**
Deposits: ☐ None ☐ Mud ☒ **Sludge** ☐ Debris ☐ Grease
Silt Depth: **1** (in.) Deposits Extent: **Light**
Infiltration: **None** Pipe Seal Cond: **Sound**

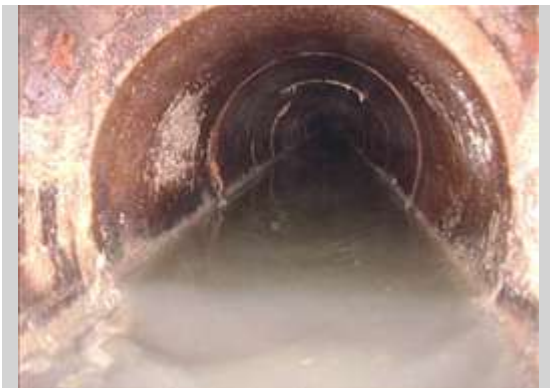
6 O'Clock Inflow

Pipe Height: **26.4** (in.) Rod and Bar (Angled)
Pipe Material: **Clay** ☐ Pipe Lined
Invert Depth: **16.54** (ft.) Flow Characteristics: **Turbulent**
Deposits: ☐ None ☐ Mud ☒ **Sludge** ☐ Debris ☐ Grease
Silt Depth: **1** (in.) Deposits Extent: **Light**
Infiltration: **None** Pipe Seal Cond: **Sound**
